Evaluation of Compliance with Environmental and Industrial Safety Standards at Kumtor Gold Mine

Report of the Interagency Governmental Commission of the Kyrgyz Republic

Bishkek - December 2011

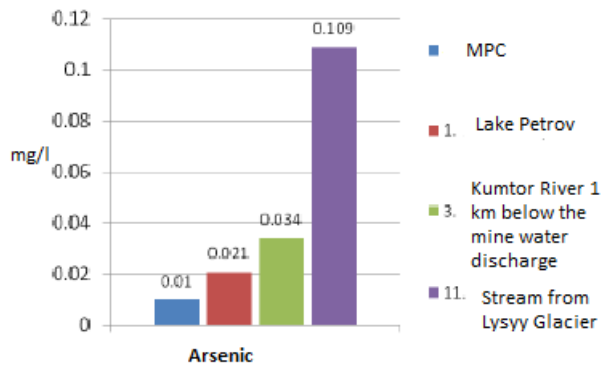
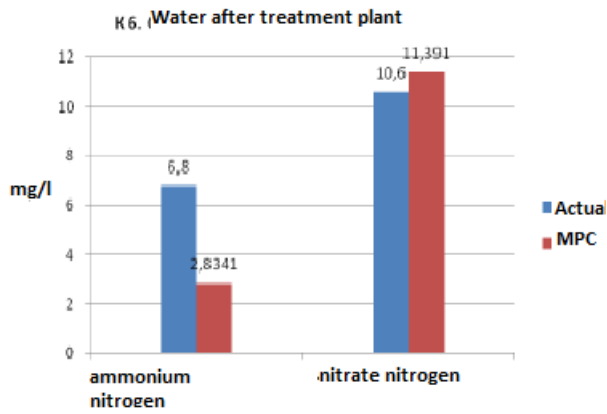
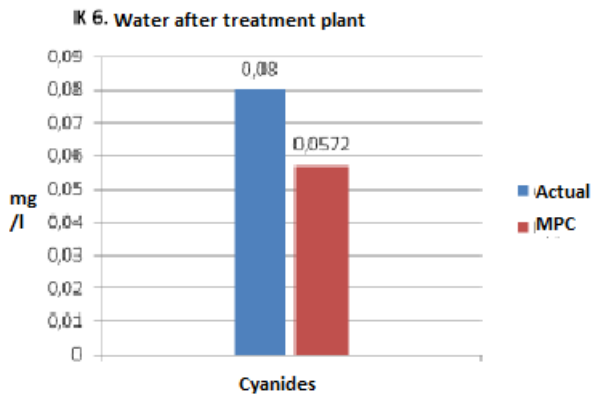
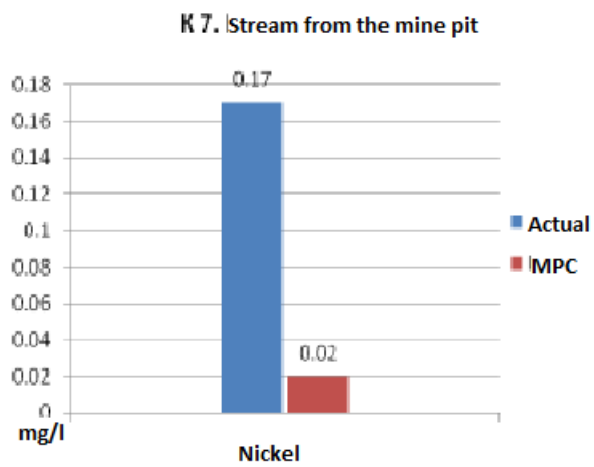
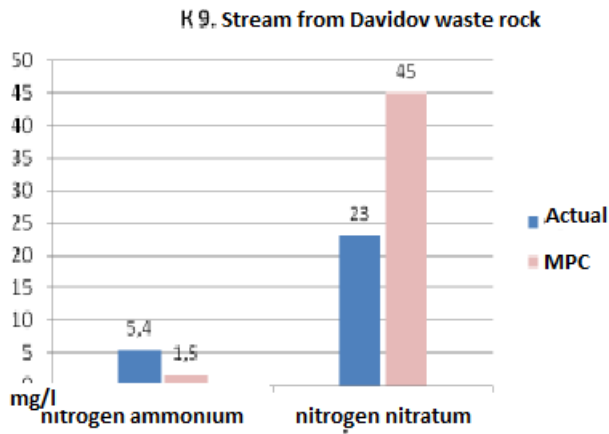
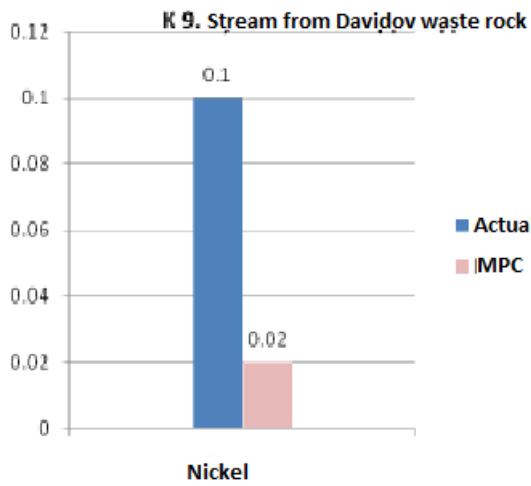
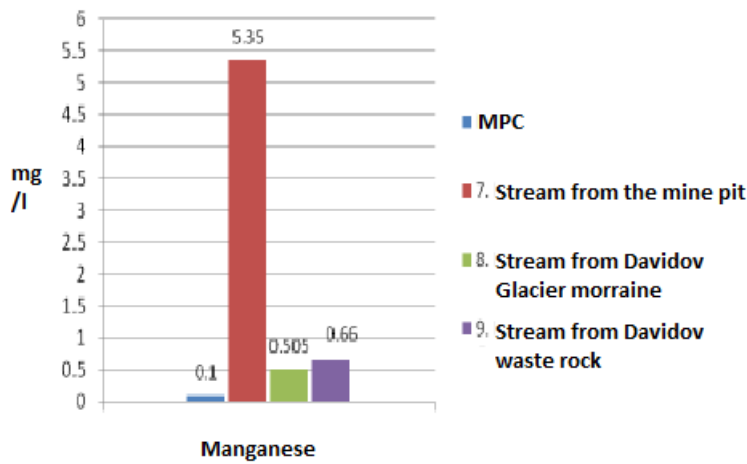
Below are the graphs showing the elements exceeding the Maximum Permissible Concentrations

Therefore, the analysis of the water samples shows the deviations from maximum allowable concentration levels observed upon treatment procedures for a number of elements including cyanides, ammonia nitrogen, sulfates, and nitrates at K⁶. The interpretation of the obtained data requires further details. Points K7, 8, 9, and 3 of the stream that connect in the Chon-Sary-Tor

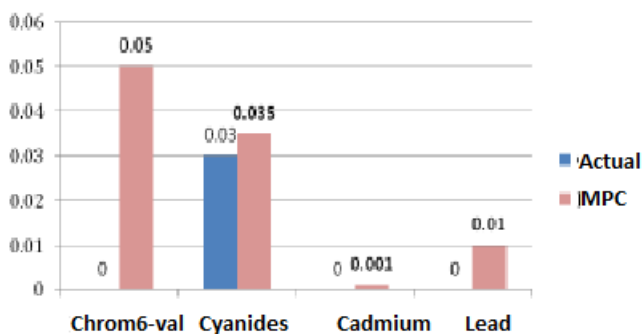
Kumtor River 7 km downstream from the mine

However, at the final point at the mine exit the analysis data show almost no deviations at all which may be evidence of safety of water discharged from the treatment facilities and the safety of water sources for the downstream settlements (see Figure below).
